SITE PROGRESS REPORT

Report No.: **2**

Project: Lake Matinenda Boat Launch Improvements

Project No.: 1744.05

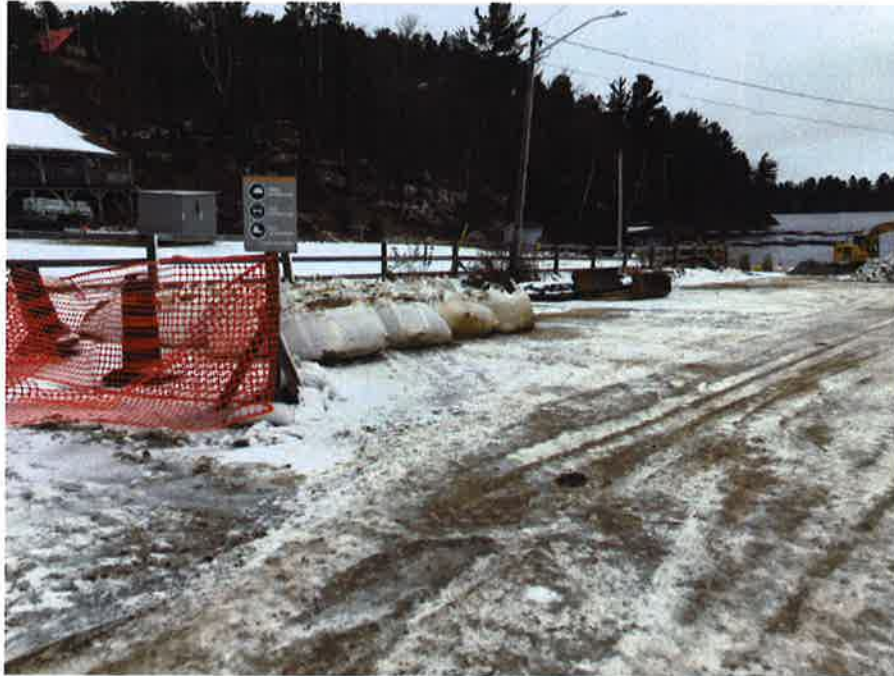
Photo 1: Site Conditions.

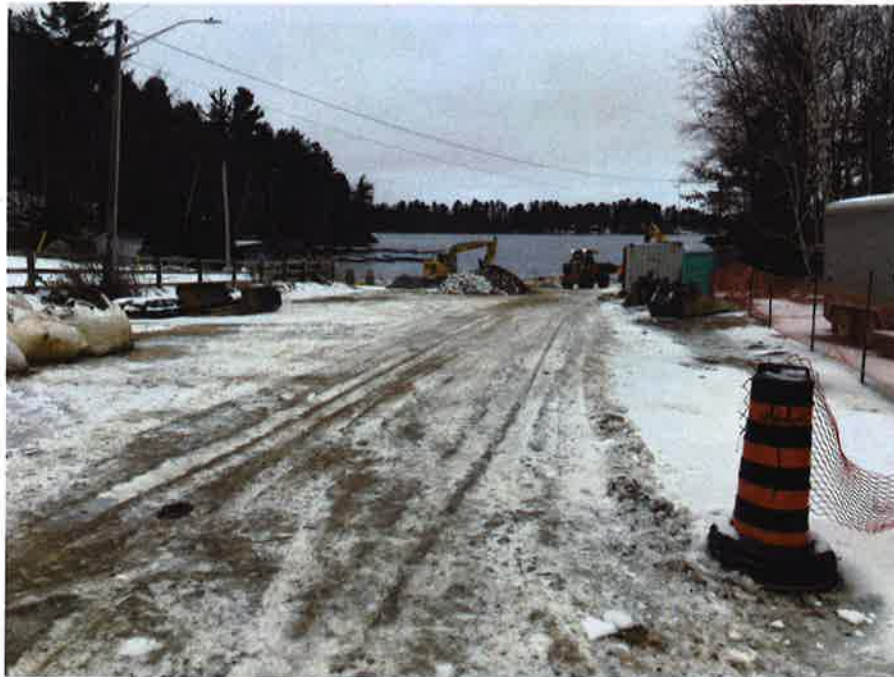
Photo 2: Site Conditions.

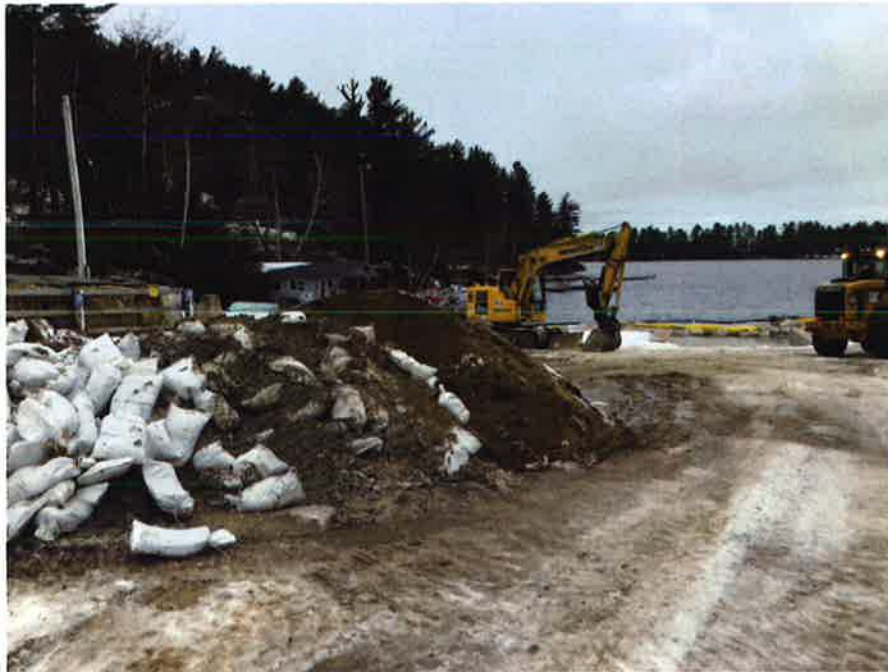
Photo 3: Progress of the Work: Sand bag removals.

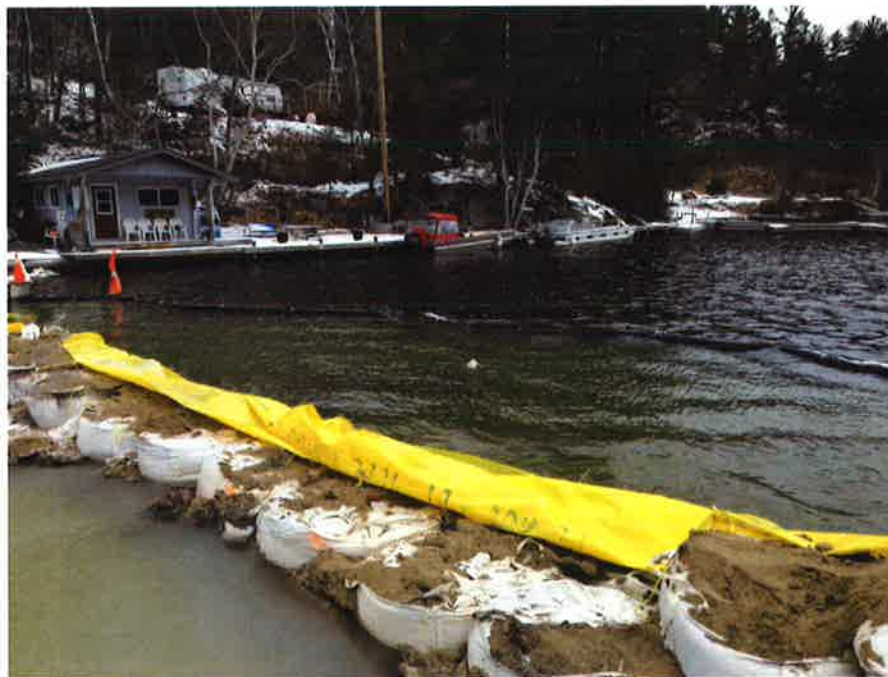
The in-water silt curtain is still in place and appears to be effective in retaining construction generated silt.

Photo 4: Progress of the Work: In-water silt curtain.

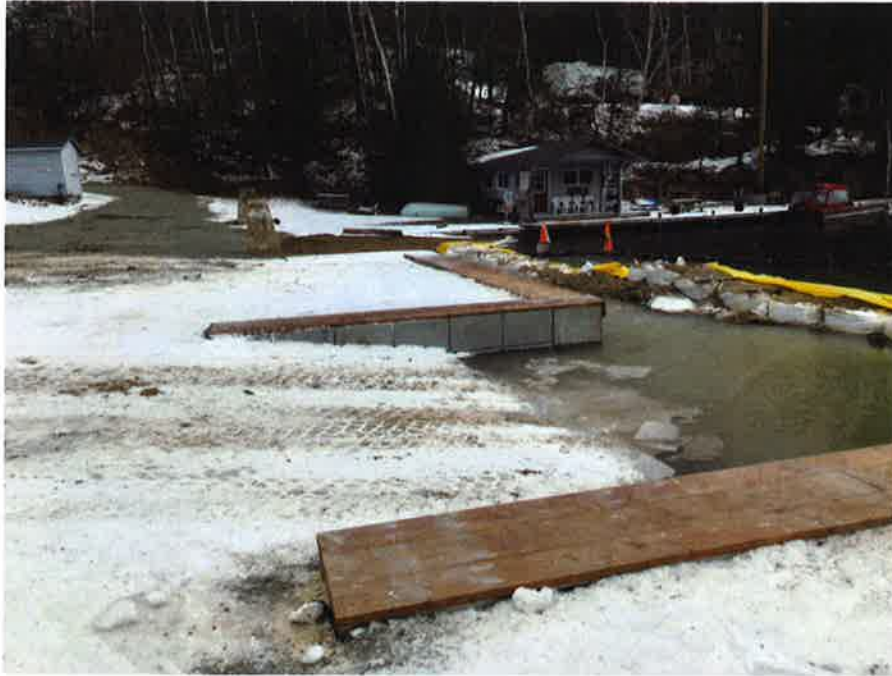
Photo 5: Progress of the Work: West section of retaining wall.

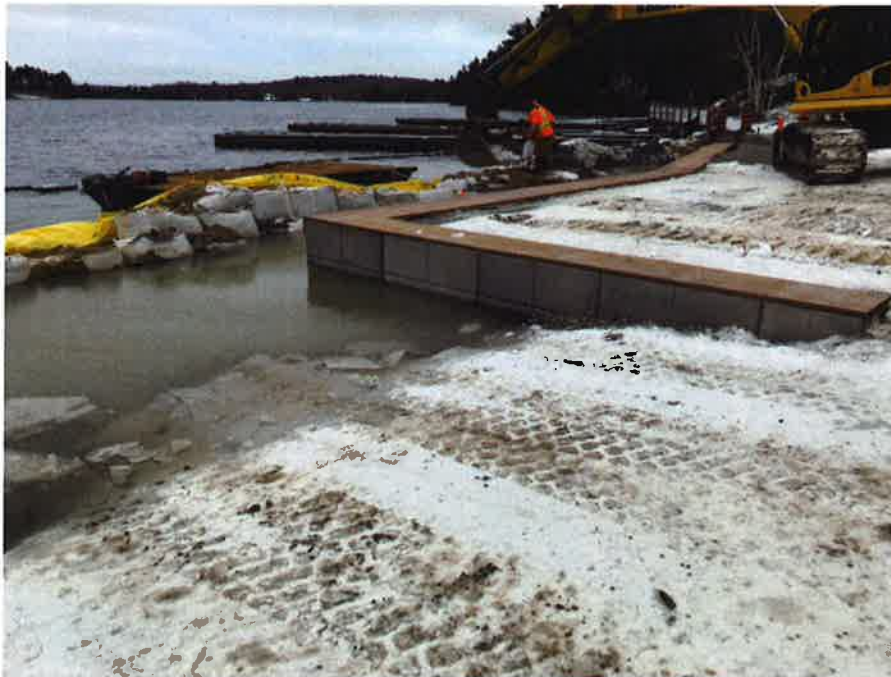
Photo 6: Progress of the Work: East retaining wall (sandbag removal in progress).

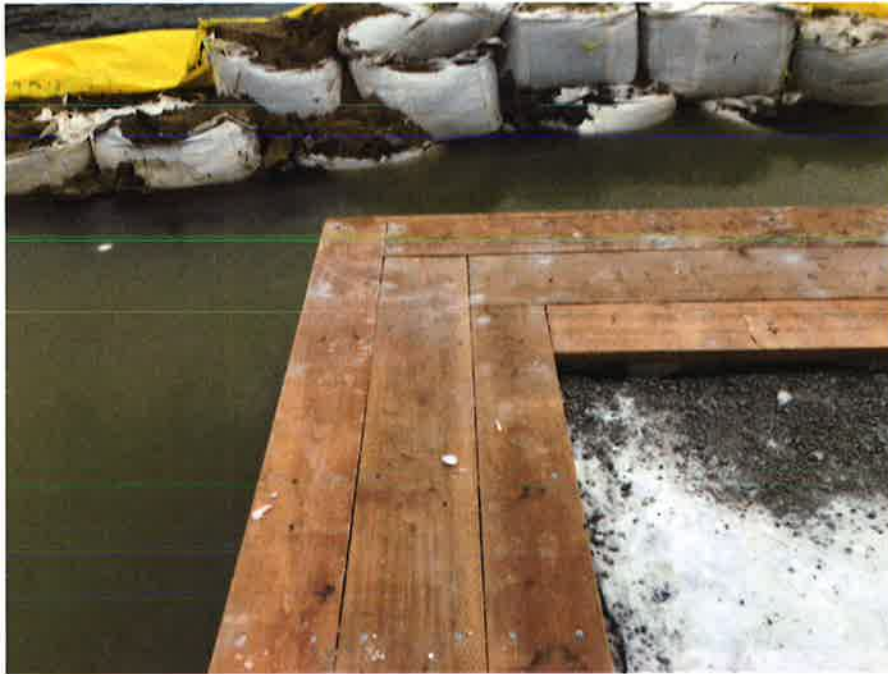
Photo 7: Progress of the Work: East wall PT wood cap.

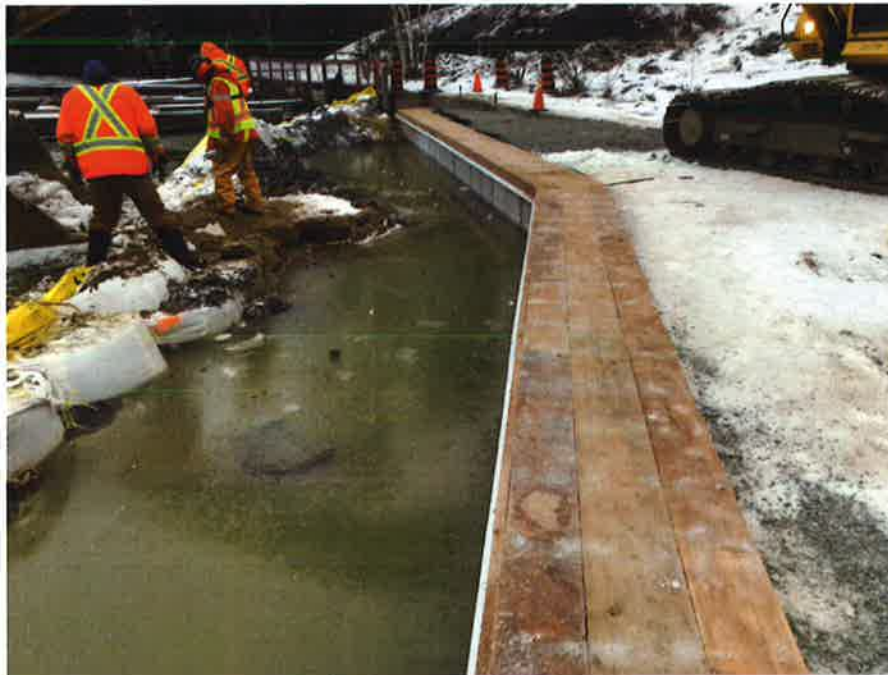
Photo 8: Progress of the Work: East wall PT wood cap, single "D" boat bumper in place.

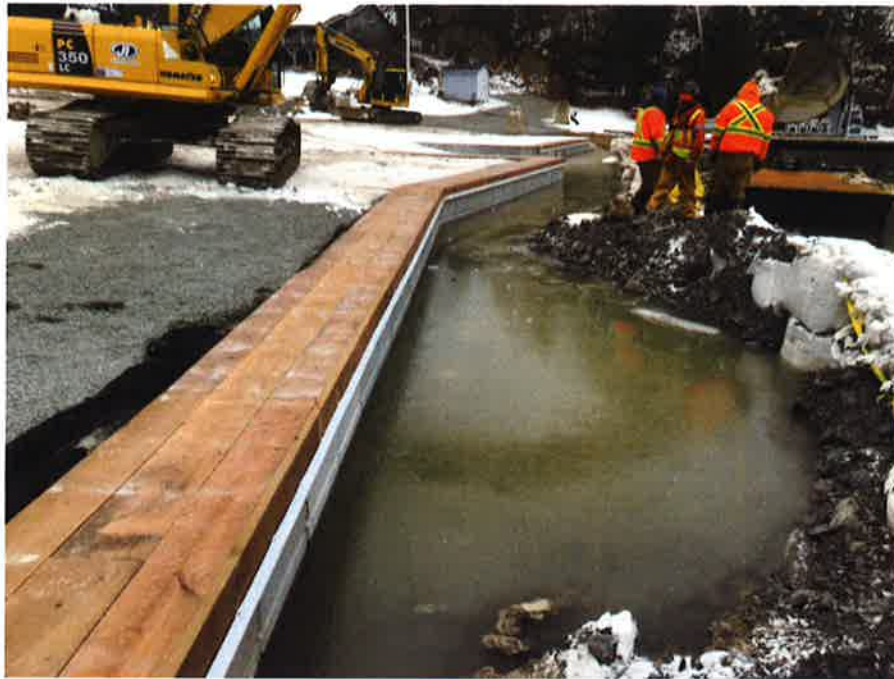
Photo 8: Progress of the Work: New retaining wall, looking west.
